# LAINDATANG WATER CONNECTIONS REPORT

Phase IV - 2025

The Laindatang Water Connections – Phase IV Project continues a sustainable clean-water initiative led by Fair Future Foundation and Kawan Baik Indonesia, and is technically implemented by CV GNADE in East Sumba.

Through the construction of a **114,500-litre rainwater harvesting system** integrated with filtration and collection mechanisms, the project now provides reliable access to clean water for more than 210 direct beneficiaries, including 160 community members and 90 students and teachers of SD Negeri Laindatang.

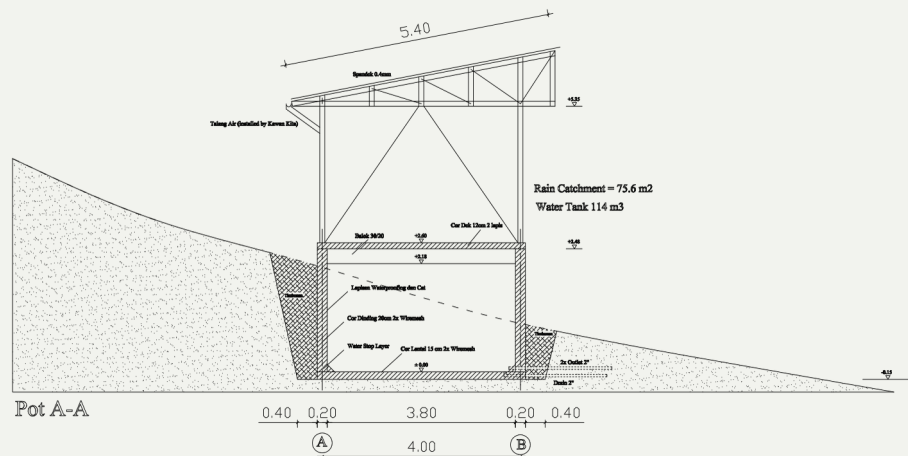
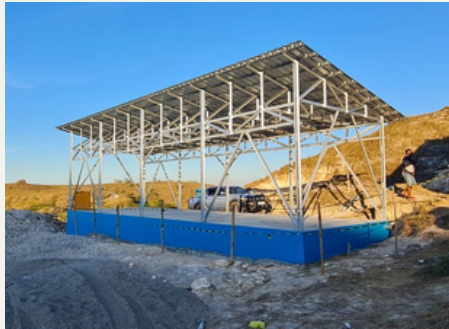
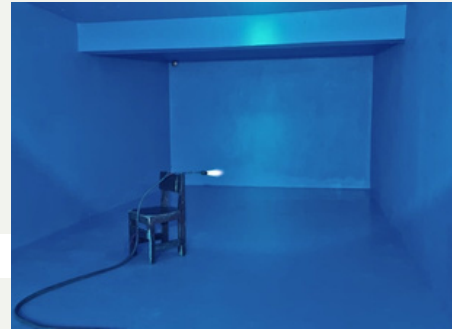
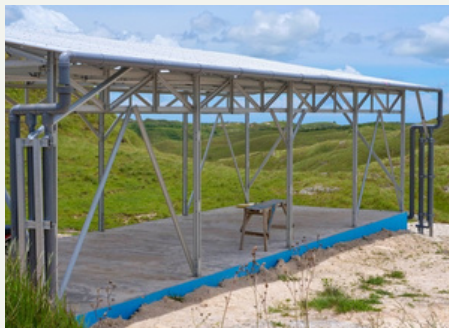
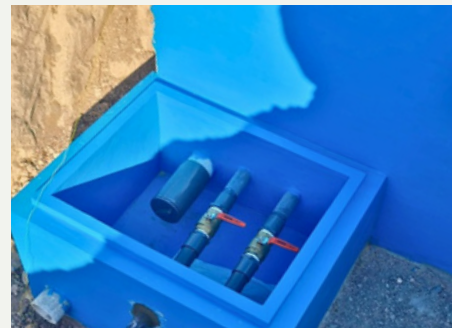
# TECHNICAL SYSTEM SPECIFICATIONS

The rainwater storage facility was constructed with an approximate capacity of 114,000 litres using reinforced concrete to ensure long-term durability.

- 20 cm thick walls reinforced with double-layer steel wire
- 15 cm floor slab with a 5% slope toward the outlet to facilitate drainage
- 12 cm reinforced concrete roof slab
- A 50 × 70 cm inspection hatch for maintenance access
- Integrated overflow channel and 2-inch drainage pipe to safely redirect excess water

Rainwater is harvested from a 75.6 m<sup>2</sup> catchment area constructed with:

- Lightweight steel framing
- 0.4 mm Spandek roofing sheets

Rainwater is collected through 4-inch gutters and directed into the reservoir via two inlet channels using 2-inch PVC pipes. Each inlet is equipped with a tubular filtration unit designed to remove debris, including leaves, stones, sand, and dust, thereby enhancing water quality and overall system efficiency.

The intake system consists of two 2-inch pipes, functioning as primary and backup lines. Water is distributed through a ½-inch outlet pipe fitted with a control valve to regulate pressure during use. A control box installed at the access point helps manage flow, minimise wastage, and ensure equitable access for all users.

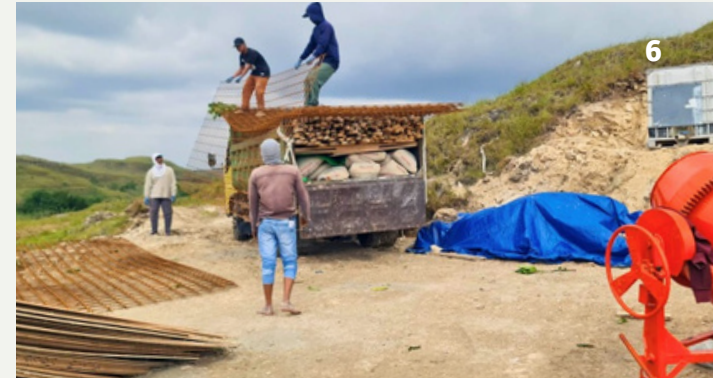
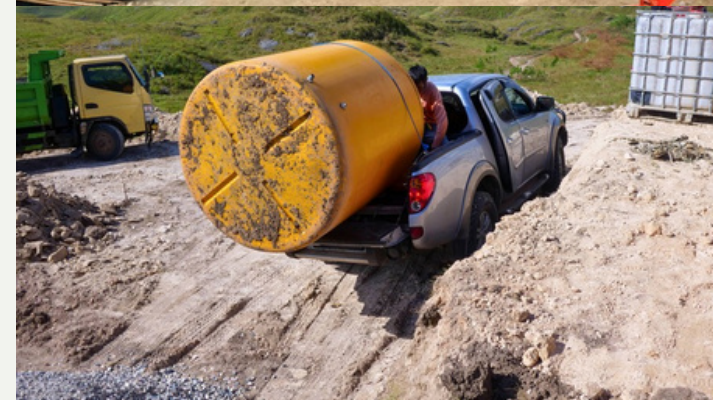
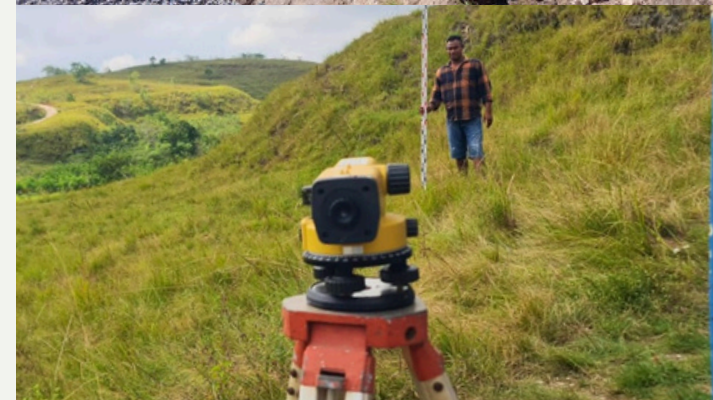
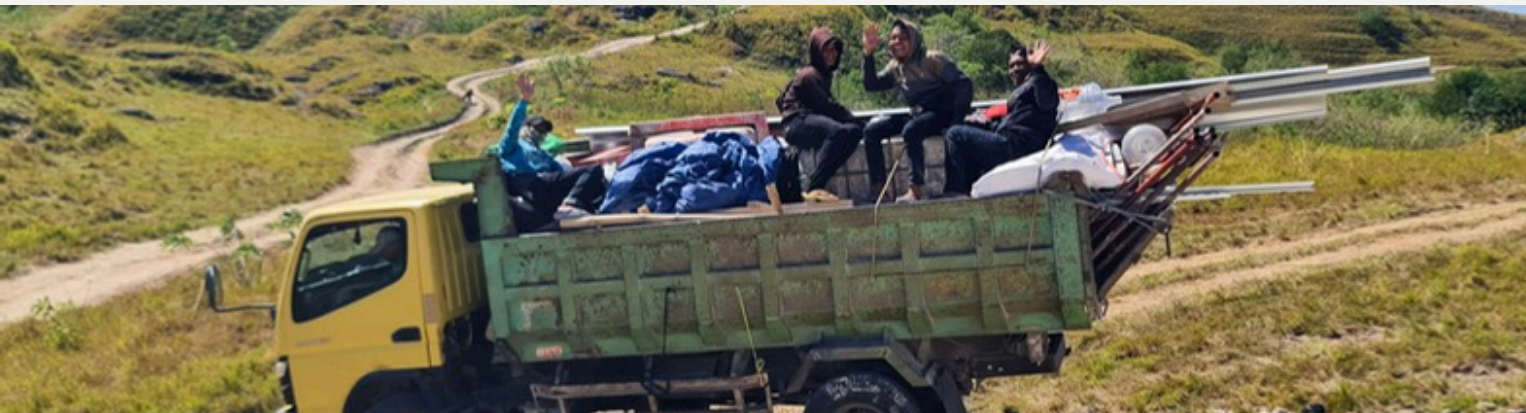
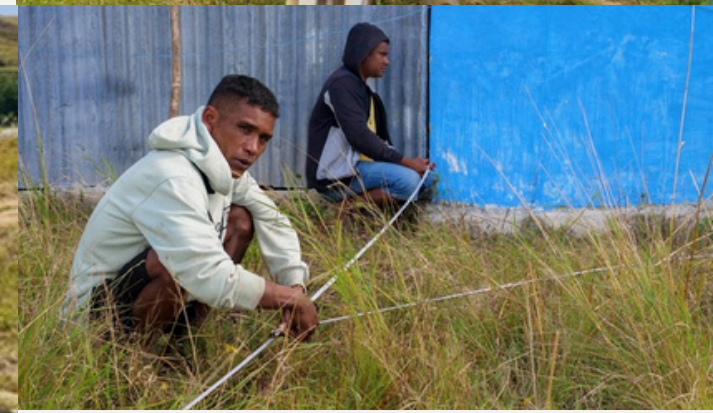
- Mobilisation of materials and equipment from Waingapu to Laindatang village, including construction tools and logistical supplies
- Site clearing and preparation, including land levelling and light backfilling for material storage areas, reservoir location, work tents, and operational zones
- Measurement and installation of bouwplank as reference points for construction dimensions, including drainage pipes, outlet, and overflow positioning under the supervision of the Head Builder
- Construction of temporary worker barracks and supporting facilities for equipment storage, rest areas, daily coordination, and provision of working water and temporary electricity

Throughout this phase, the team ensured that activities did not disrupt community routines and established safety zones around the project site. This stage provided the essential technical and social foundation prior to earthworks and core construction activities.

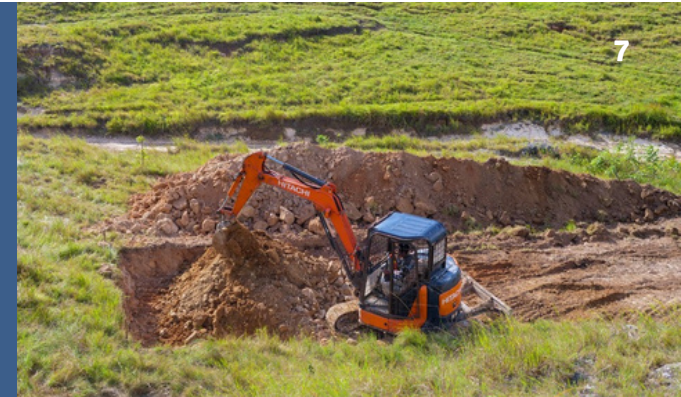
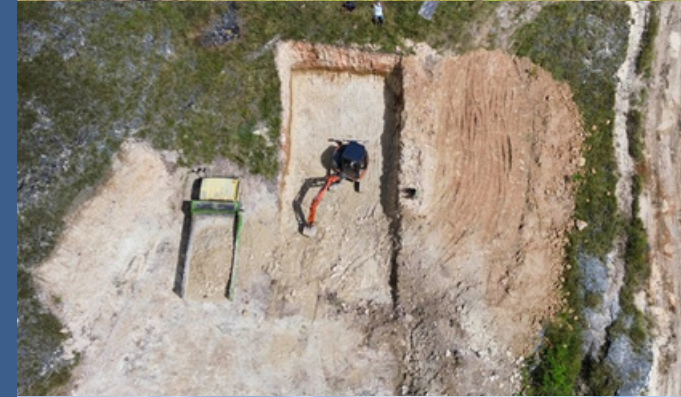
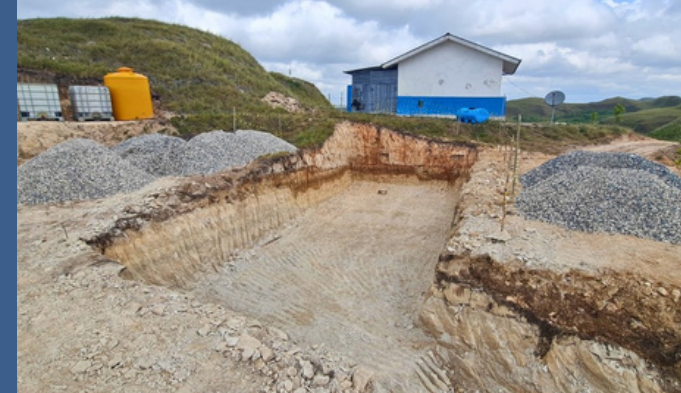
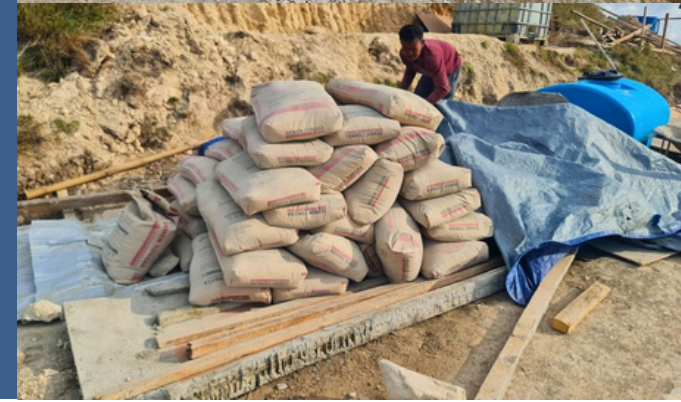
# EARTHWORKS

Earthworks constituted the first structural phase of the construction process, aimed at establishing the reservoir base, ensuring adequate soil bearing capacity, structural stability, and foundation readiness before reinforcement and concrete works. This phase was completed over three days, from June 9–11, 2025.

Excavation was carried out using a mini excavator in accordance with design dimensions ( $L\ 12\ m \times W\ 5\ m \times D\ 2\ m$ ) to reach the required formation level. Following excavation, manual trimming and levelling were conducted to achieve the specified elevation and slope tolerances.

The excavation base was compacted and overlaid with approximately 5 cm of sand bedding, serving as a blinding layer. This layer functions to:

A geomembrane plastic sheet was then installed above the sand layer as a moisture barrier and seepage control layer. Overlapping installation was applied at joints to maintain watertight integrity.

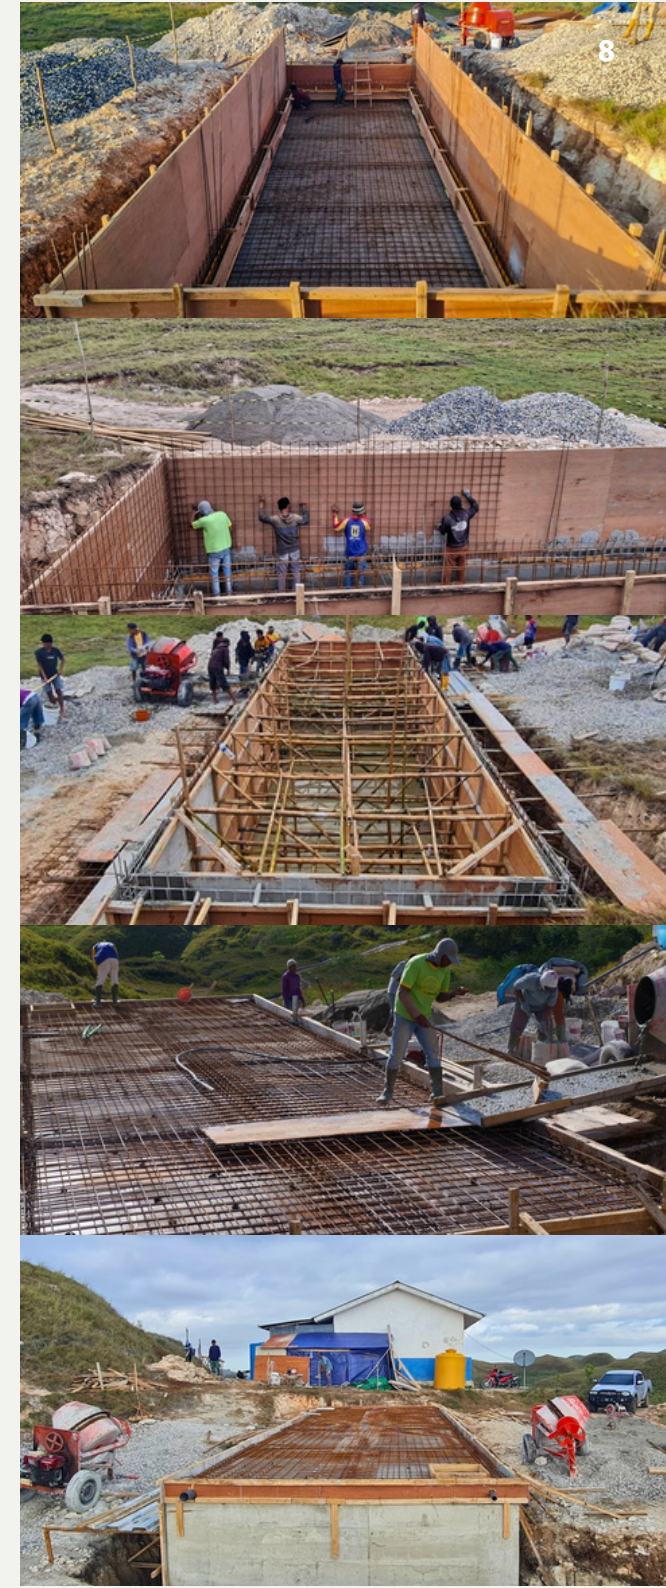
## STRUCTURAL & FOUNDATION WORKS

The storage tank base was constructed with Ø10 mm double-layer wire mesh reinforcement.

The 20 cm main slab and lower tie beam were cast simultaneously to form a monolithic base structure. Formwork was removed after initial concrete setting.

- Ø10 mm double-layer wiremesh
- Ø12 mm practical columns installed at 10 structural points

- Internal formwork with angular bracing was installed
- Wall casting was completed
- Formwork was removed once sufficient concrete strength was achieved.

- Ø10 mm and Ø8 mm steel bars

- 3 primary support beams measuring 20 × 40 cm

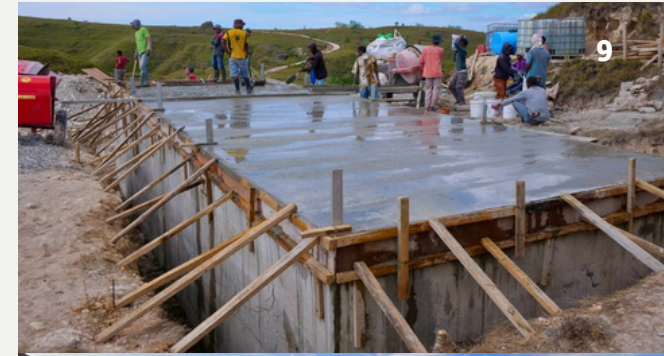
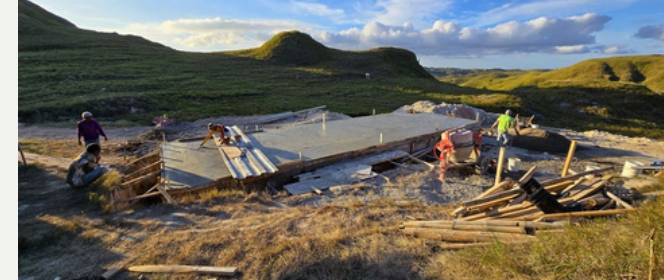
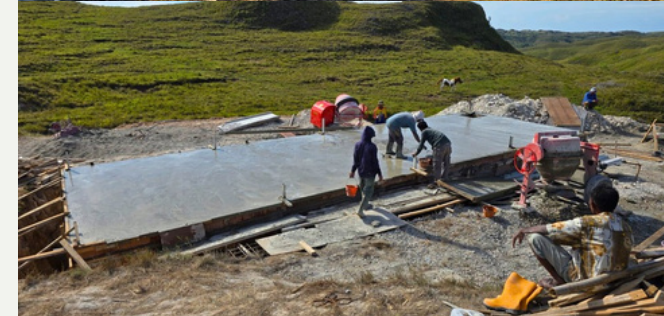
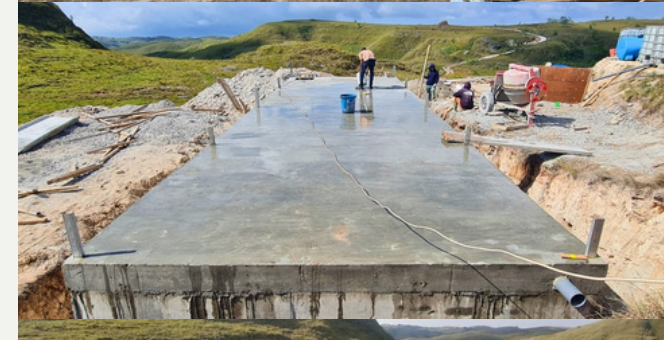
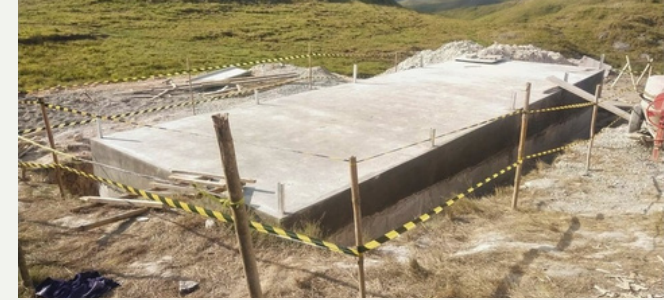
## RESERVOIR STRUCTURAL SPECIFICATIONS

- Installation of beam and slab formwork
- Casting of the tank cover slab with a thickness of approximately 12 cm
- Formwork removal after curing
- Surface finishing using cement plaster to ensure smoothness and watertight sealing

- External tank dimensions: 12.70 m × 4.70 m × 2.70 m
- Internal dimensions: 12.30 m × 3.80 m
- Base slab thickness: approx. 20 cm
- Wall thickness: approx. 22 cm
- Primary reinforcement: Ø10 mm wiremesh (*double layer*)
- Practical columns: Ø12 mm
- Support beams: 3 units (20 × 40 cm)
- Cover slab thickness: approx. 12 cm

**Concrete Mix Ratio:** 1 cement : 3 matex sand: 4 matex crushed stone + Aditon admixture for enhanced strength and waterproofing performance.

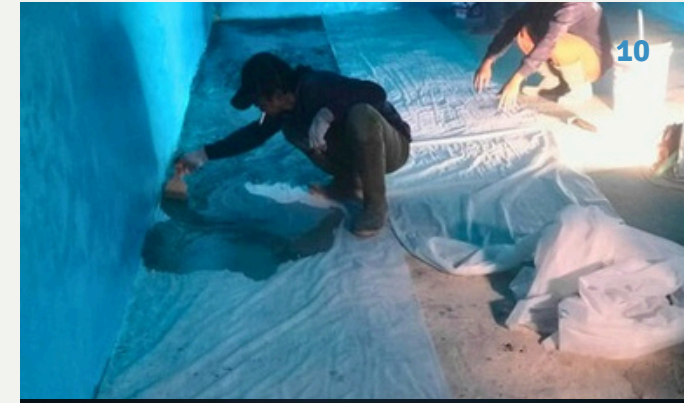
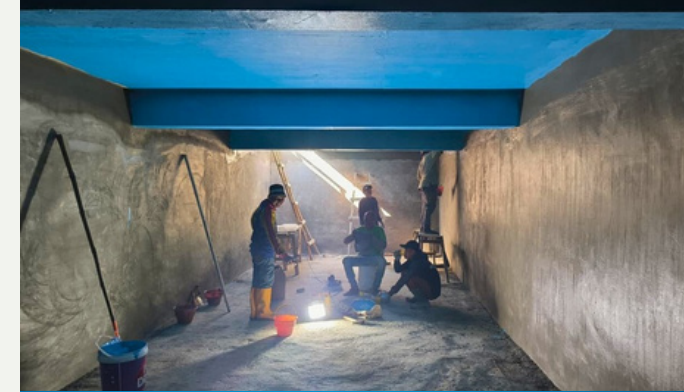
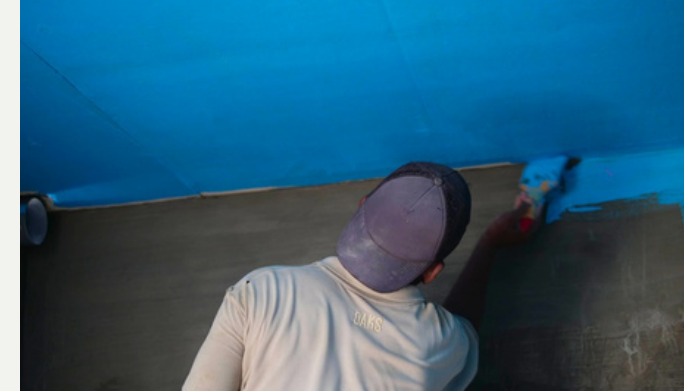
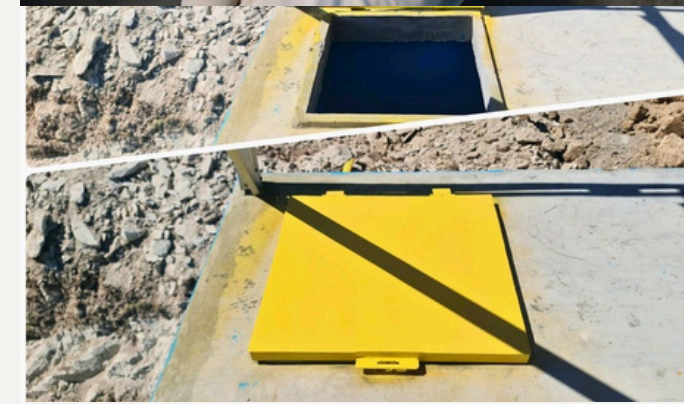
## STRUCTURAL FINISHING & WATERPROOFING WORKS

At structural junctions, particularly wall-to-floor connections, polymesh reinforcement was installed to accommodate structural movement and hydrostatic stress.

A fine cement skim coat followed this stage to create a dense, smooth surface suitable for a waterproofing application.

- Bonding Layer:
  - Cement mixed with SikaLatex to enhance adhesion and flexibility.
- Primary Waterproof Layer:
  - Two applications of cement-based waterproofing with liquid admixture (*Aditon*), applied using cross-brush techniques for even distribution.
- Protective Finishing Coat:
  - Blue Sika waterproof coating provides additional seepage protection and improved visibility during inspections.

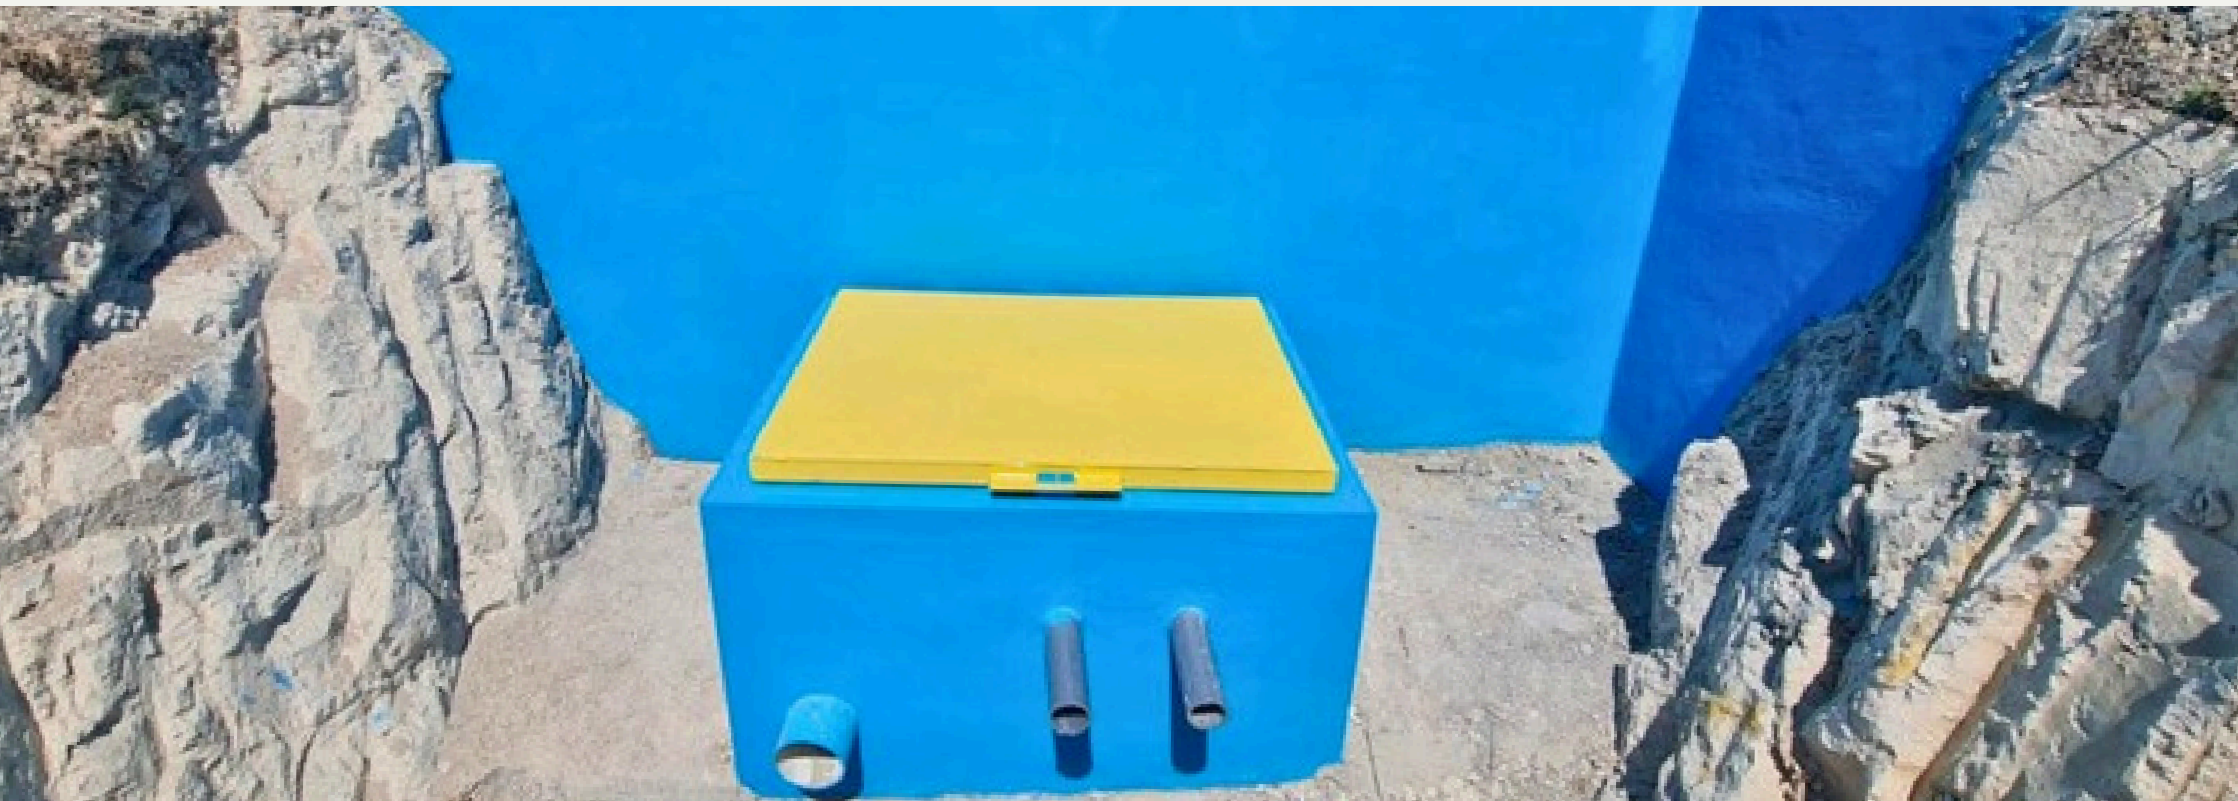
- Permanent access ladder
- Secured top cover

- ±1 mm steel plate
- Steel angle frame
- Hinged locking mechanism

- Protective brick enclosure
- Plastered and waterproofed surfaces
- Spandek roofing for weather and contamination protection

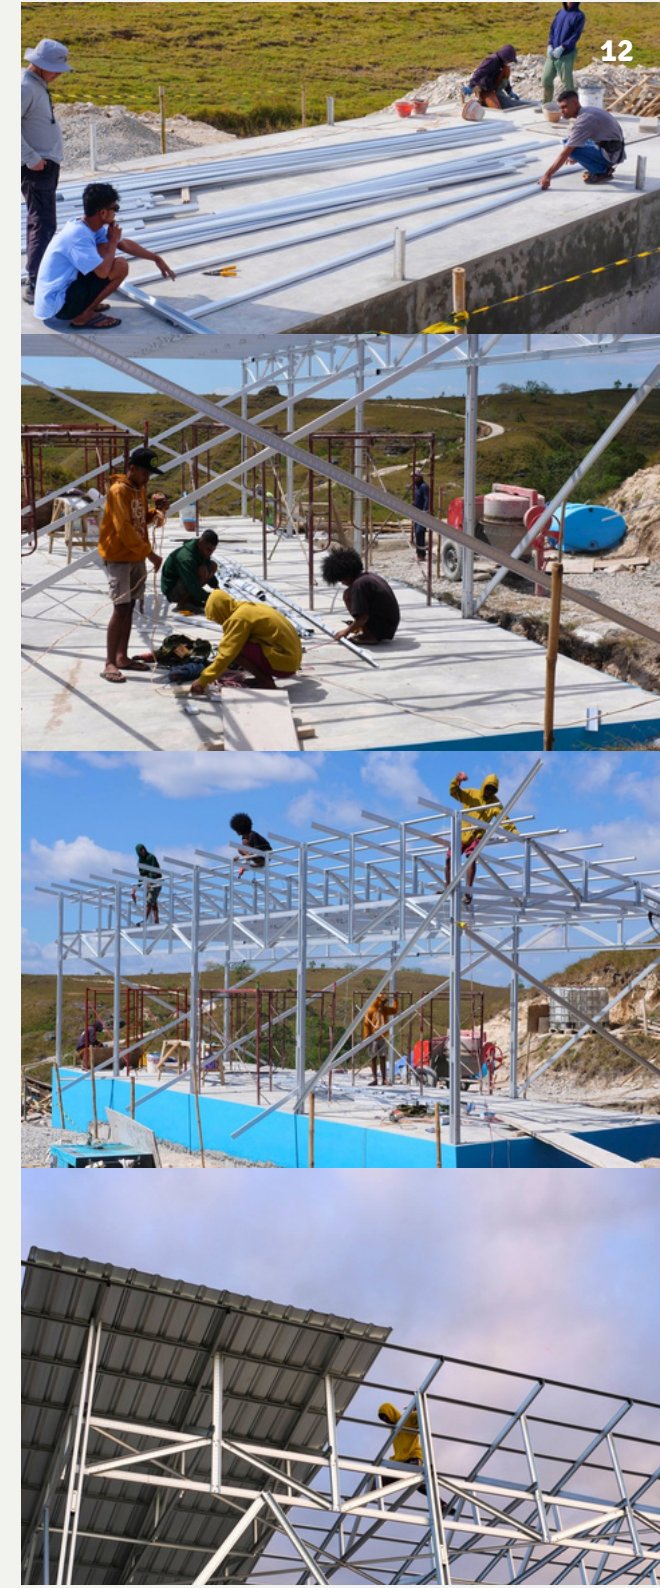
# ROOF STRUCTURE & RAINWATER CATCHMENT SYSTEM

- Material: Galvanised lightweight steel (*C75 profile*)
- Thickness: 0.75 mm
- Span dimensions: 12.50 m × 4.00 m
- Roof slope: approx. 15°

- Material: Aluminium–zinc spandek
- Thickness: 0.35 mm
- Installation system: Anti-rust self-drilling screws

Rainwater flows along the roof slope into gutters and downspout pipes, then into the filtration unit before entering the main reservoir, which has a capacity of approximately 114 m<sup>3</sup>.

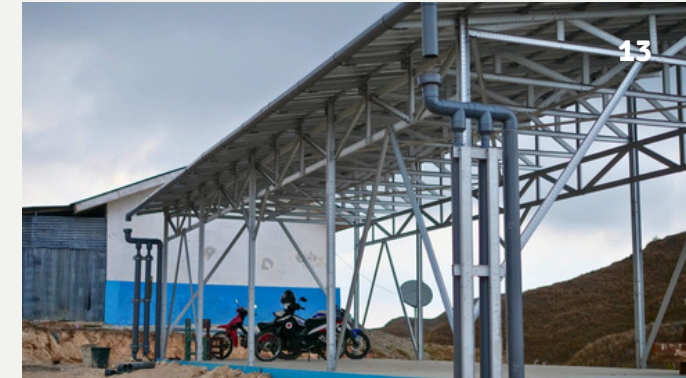
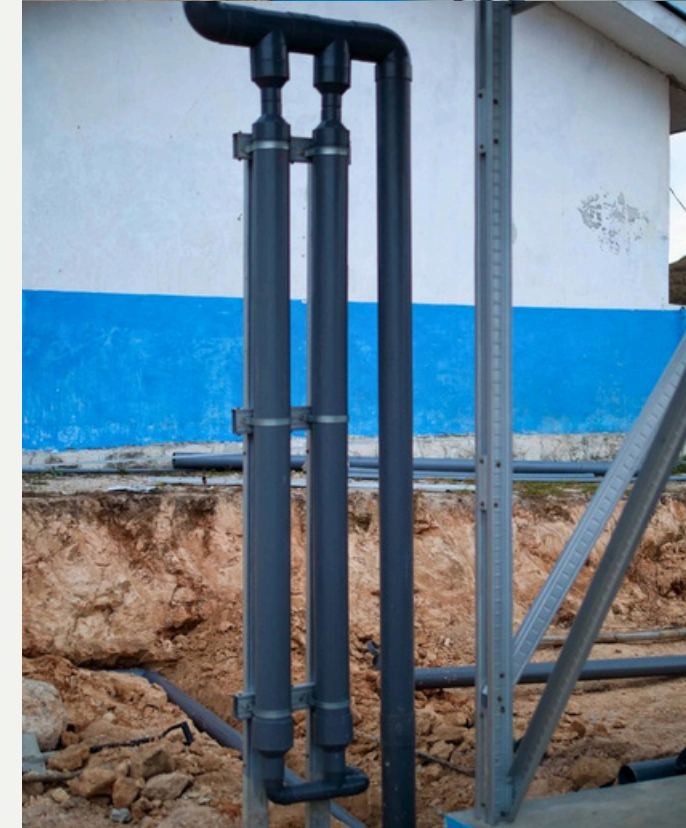
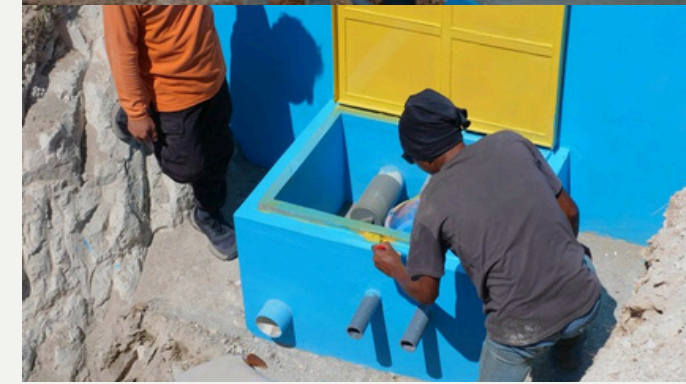
## PIPING & RAINWATER FILTRATION SYSTEM

4-inch PVC gutters were installed along the spandek roof edges with an approximate 2% slope, directing water flow to both sides toward two filtration units before entering the main tank.

- **Outlet:** 2-inch PVC pipe equipped with a ball valve for water usage.
- **Drainage:** 2-inch PVC pipe for tank cleaning and water discharge.
- **Overflow:** 2-inch PVC pipe enabling automatic overflow release when maximum capacity is reached.
- **Control Box:** Constructed to protect the outlet and drainage valves and ensure safe operation.

Each unit consists of a 4-inch PVC filter chamber with a two-stage filtration process:

- **Primary Filter:** Stainless steel mesh to capture larger debris such as leaves and coarse particles.
- **Secondary Filter:** An additional filtering layer to remove finer particles and improve water quality.

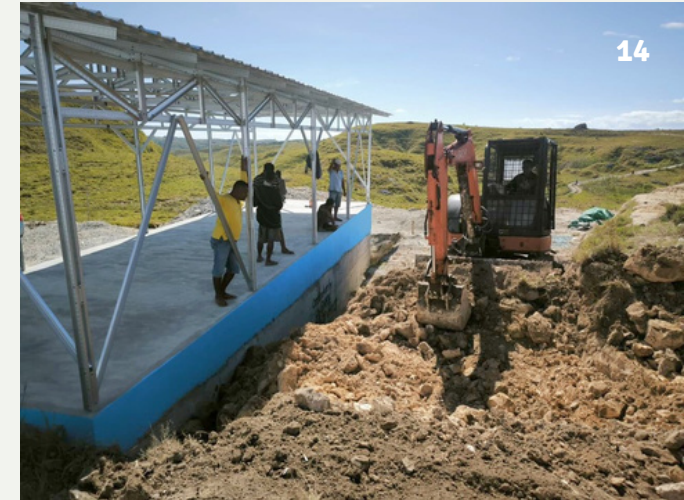
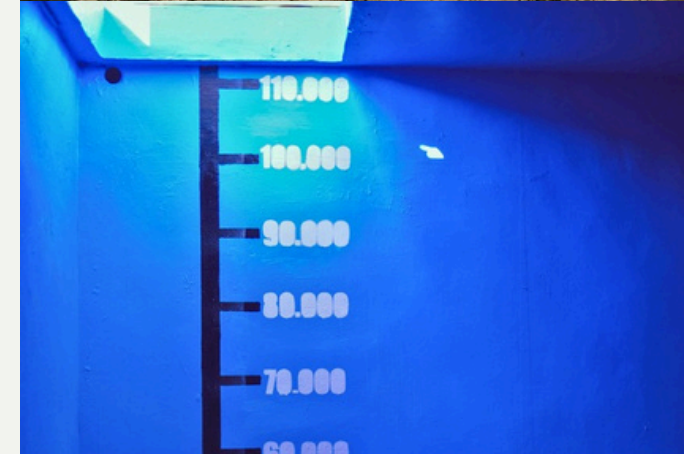
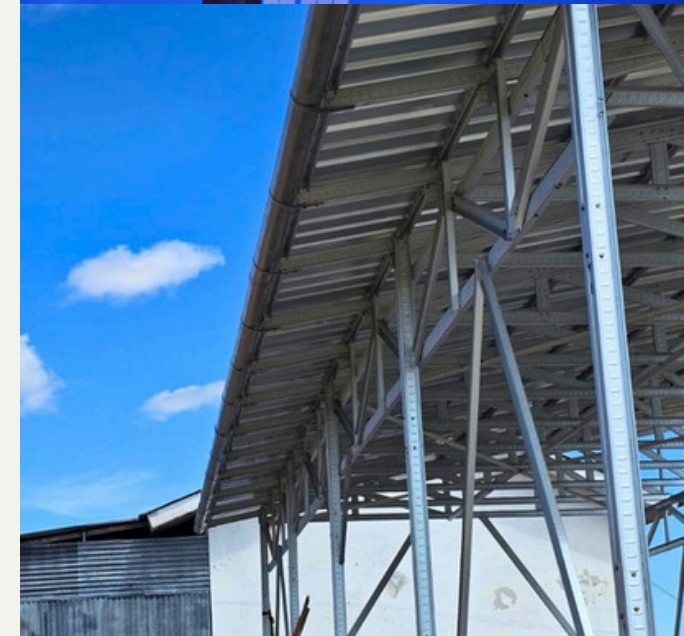
## FINALISATION & OPERATIONAL READINESS TESTING

- Concrete Structure:
  - Checked for micro-cracks or potential seepage.
- Waterproofing Layers:
  - Reassessed to ensure maximum watertight performance.
- Roof Frame & Covering:
  - Tested for structural stability and wind resistance.
- Piping & Filtration System:
  - Flow tests were conducted during rainfall to ensure there were no leaks, blockages, or disruptions to flow.

- Effective rainwater capture
- Smooth flow through filtration units into the reservoir
- Proper functioning of overflow and drainage mechanisms

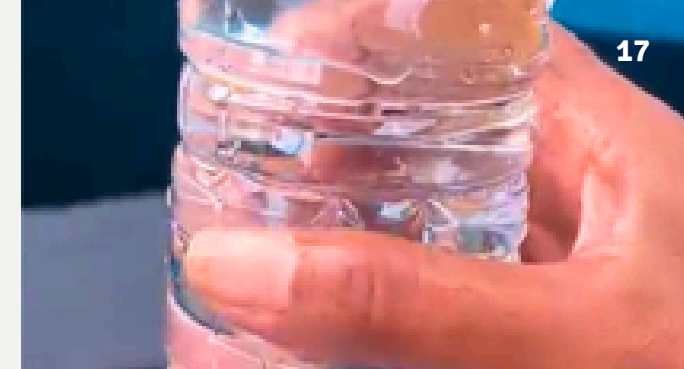
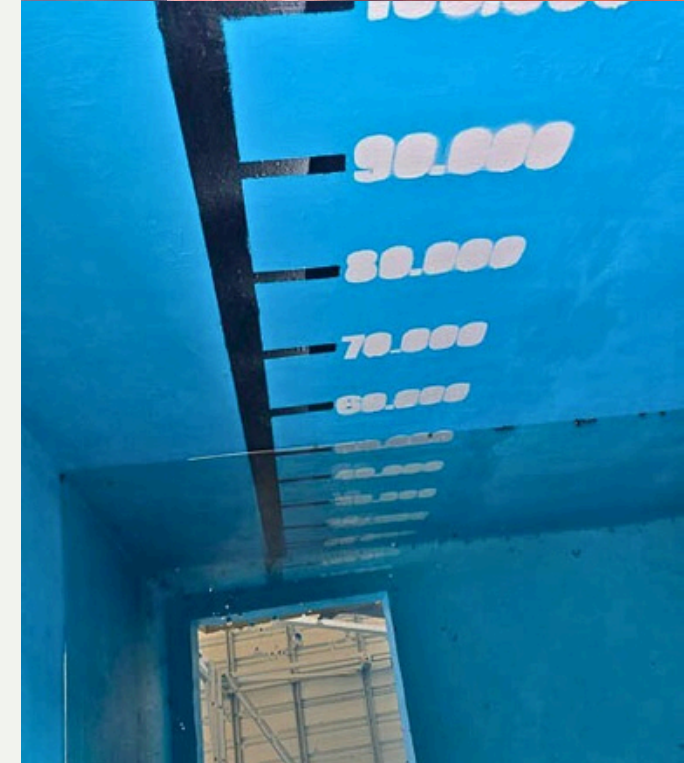
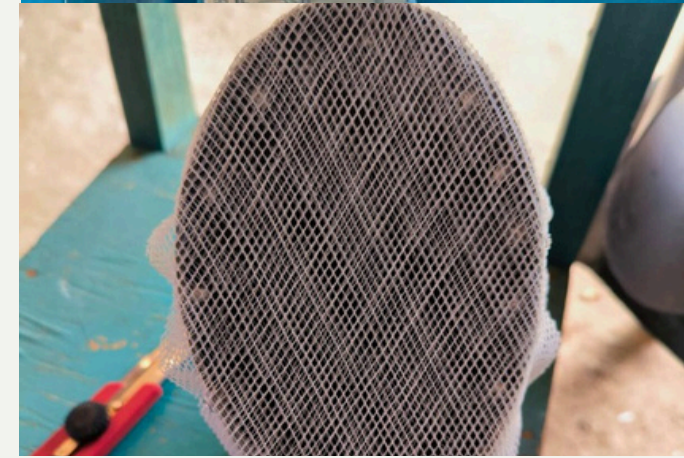
# MONITORING AND EVALUATION

Since December through January, consistent rainfall has allowed the tank to reach full capacity at approximately 114 m<sup>3</sup>, demonstrating that the storage system is functioning effectively and can capture significant rainwater volumes during peak season.

The main reservoir structure, foundation, roof system, and supporting construction remain in good condition. No cracks, leakage, or structural weaknesses were identified during inspection.

Overall, the installation of piping, filtration components, and overflow mechanisms is functioning properly without major issues.

During direct observation under rainfall conditions, minor improvements are required in parts of the rainwater catchment installation. Adjustments are needed to optimise water flow efficiency and prevent potential overflow at specific connection points. These improvements are technical refinements and do not affect the overall functionality of the system.

Minor technical adjustments to the rain catchment installation will be implemented to further optimize performance. Aside from these refinements, the building structure and overall installation are stable and functioning well.
