REPORT HAMBARITA WATER CONNECTIONS - PHASE I

HAMBARITA WATER CONNECTIONS
PHASE I - ACCESS TO CLEAN WATER FOR THE HAMBARITA COMMUNITY

FEROCEMENT TANK 4,4 m³ WAI MA HAMMU

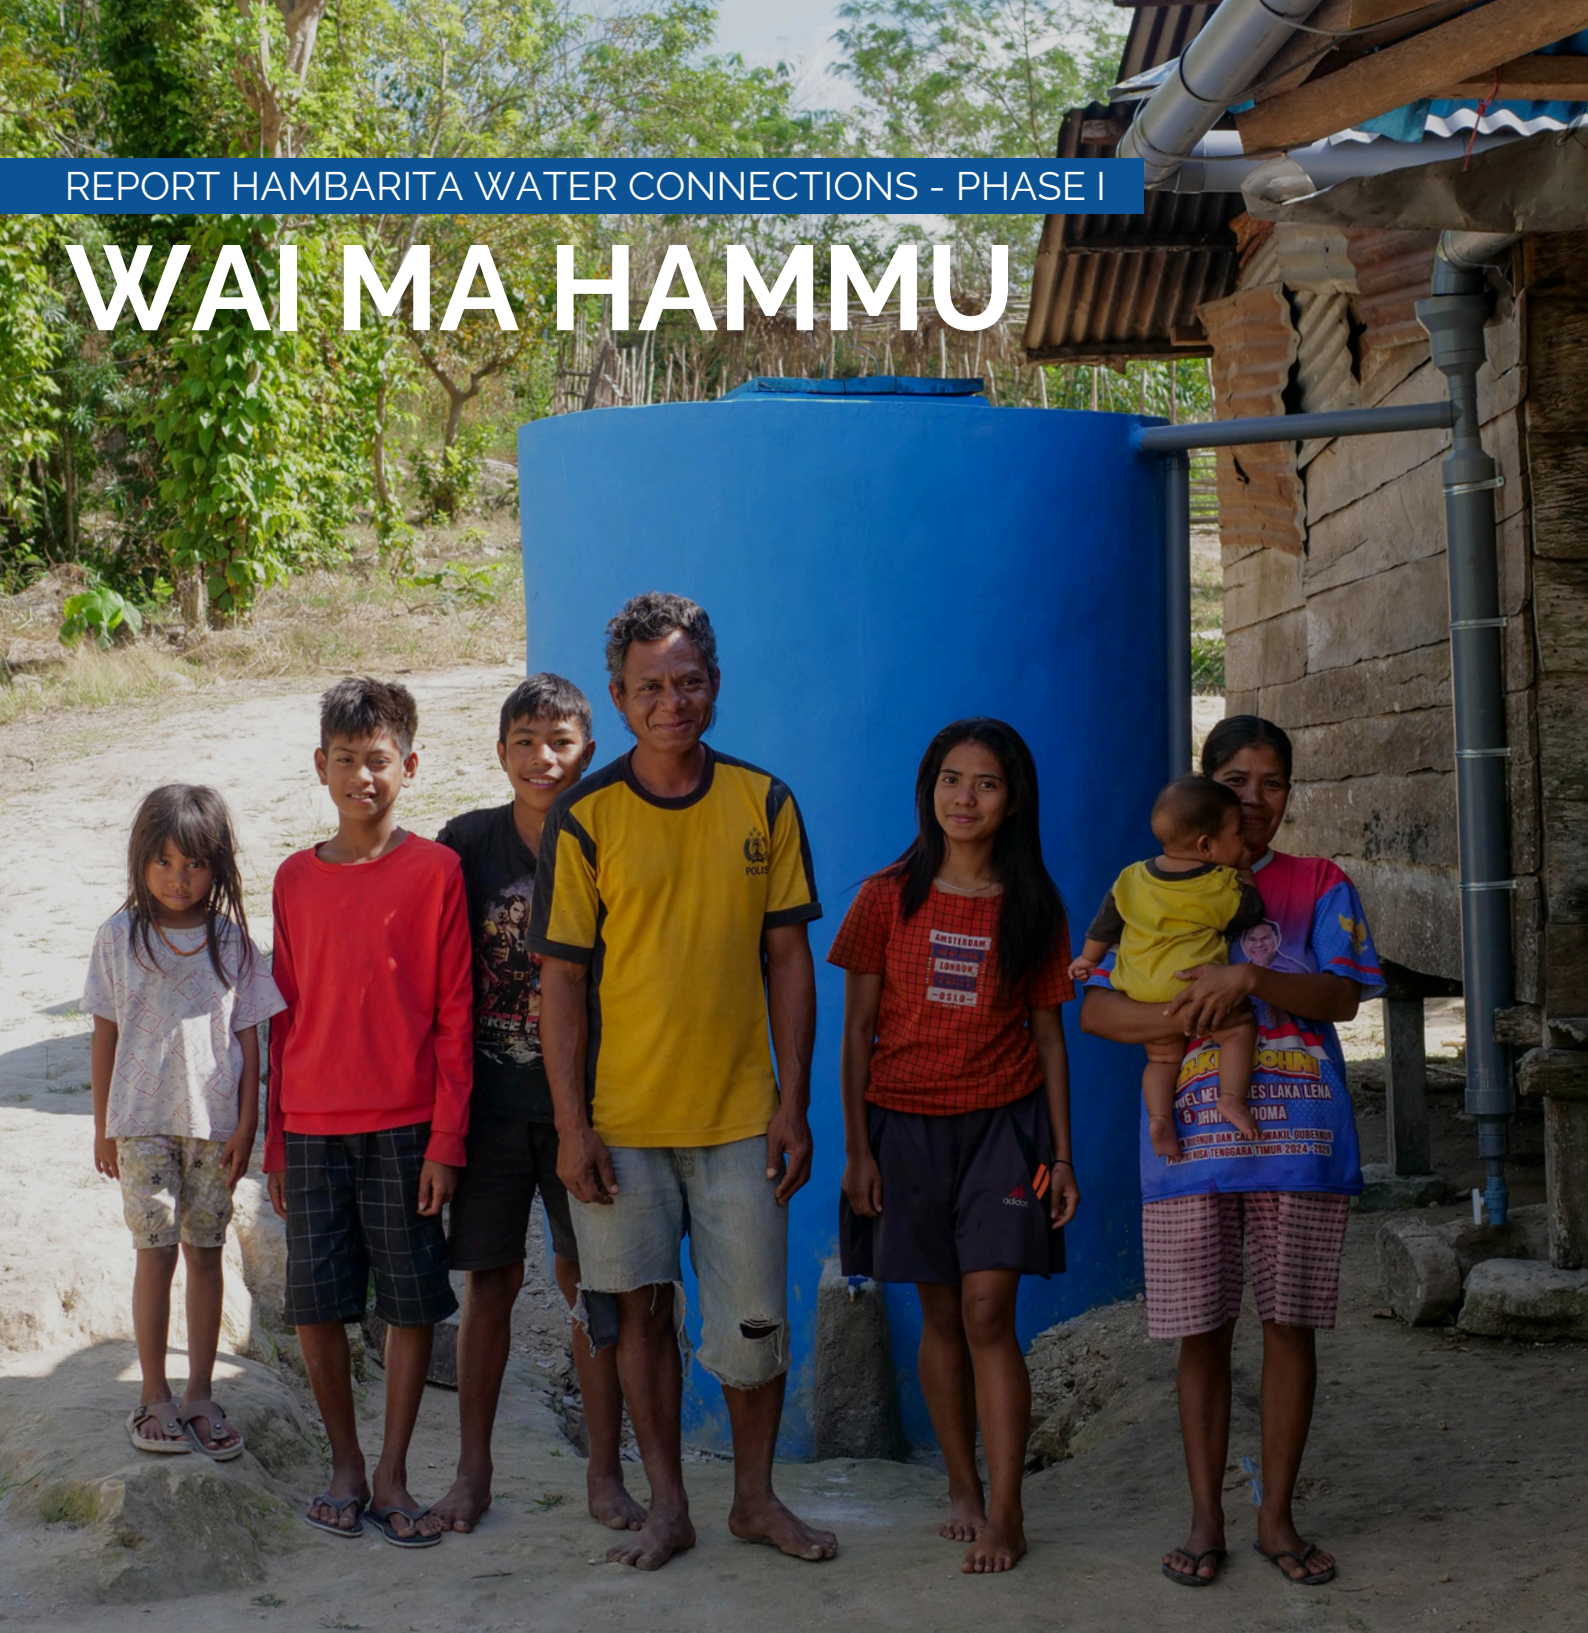
Wai Ma Hammu Tank

The Wai Ma Hammu (The Best Water) Ferrocement Tank, which was completed on June 5, 2025, is a water tank that was built manually by the hands of local residents together with the foundation.

Located in the **Ndawa Kahindu** family home, it can accommodate ± 15 people. It's semi-buried to maintain temperature and prevent contamination. It was built using cement, sand, wire, water, and, most importantly, mutual cooperation and solidarity.

Radius (r): 77 cm
Height (h): 244 cm
Thickness (l): 3 cm
 π : 22/7 or 3,14

$V = \pi \times r^2 \times h$
To calculate the volume (V) in the tank, first find (r - l) before using the volume formula

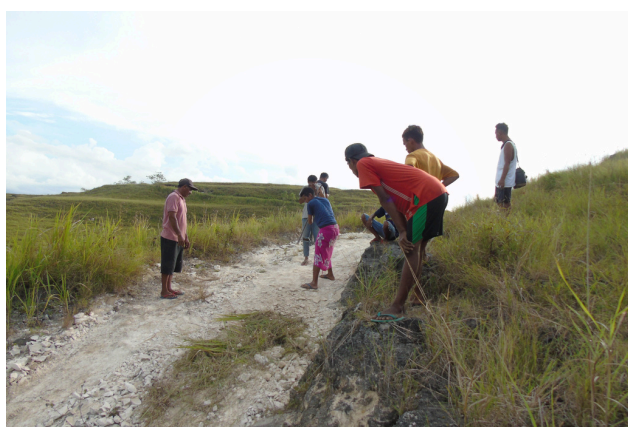
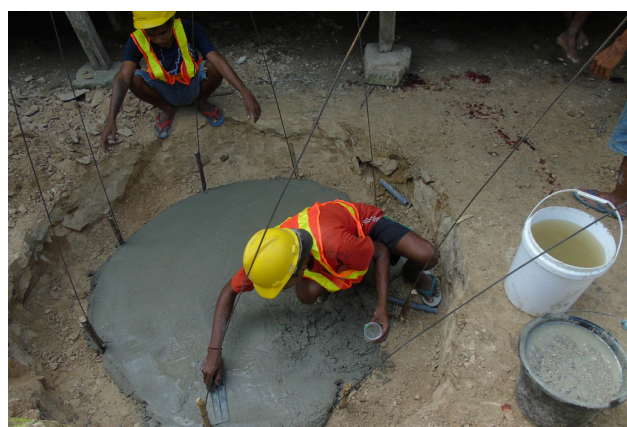
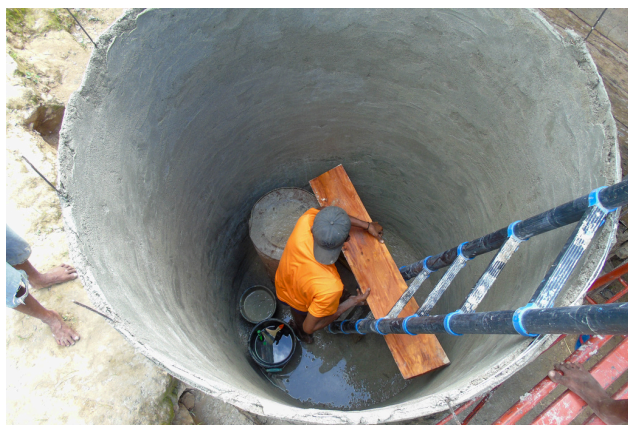
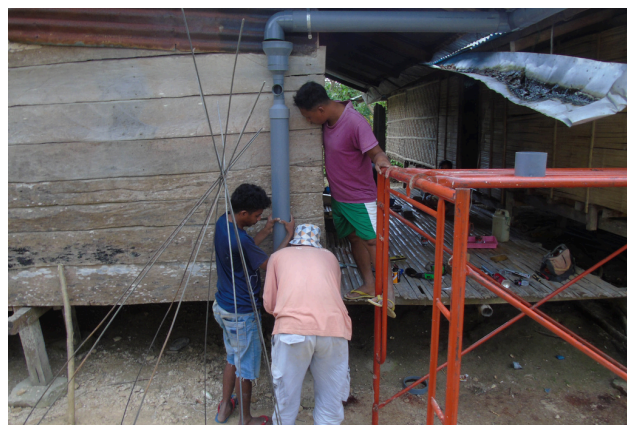
The Story of the Wai Ma Hammu

The first week focused on material distribution, site clearing, foundation assembly, tank mold installation, interior and exterior plastering, and pipe installation. Nine people participated in construction and 15 in unloading materials. Roof rain gutter installation took place on May 27–28 with the assistance of professionals.

Work was delayed due to rain and a bereavement, but was rescheduled. By the end of the second week, progress had reached 70%. The second week focused on finishing, casting the ferrocement water tank cap, and painting. With favorable weather, the work was fully completed by June 8, 2025.
