REPORT HAMBARITA WATER CONNECTIONS - PHASE I

WAI PANDULANG

HAMBARITA WATER CONNECTIONS
PHASE I - ACCESS TO CLEAN WATER FOR THE HAMBARITA COMMUNITY

FEROCEMENT TANK 5,3 m³ WAI PANDULANG

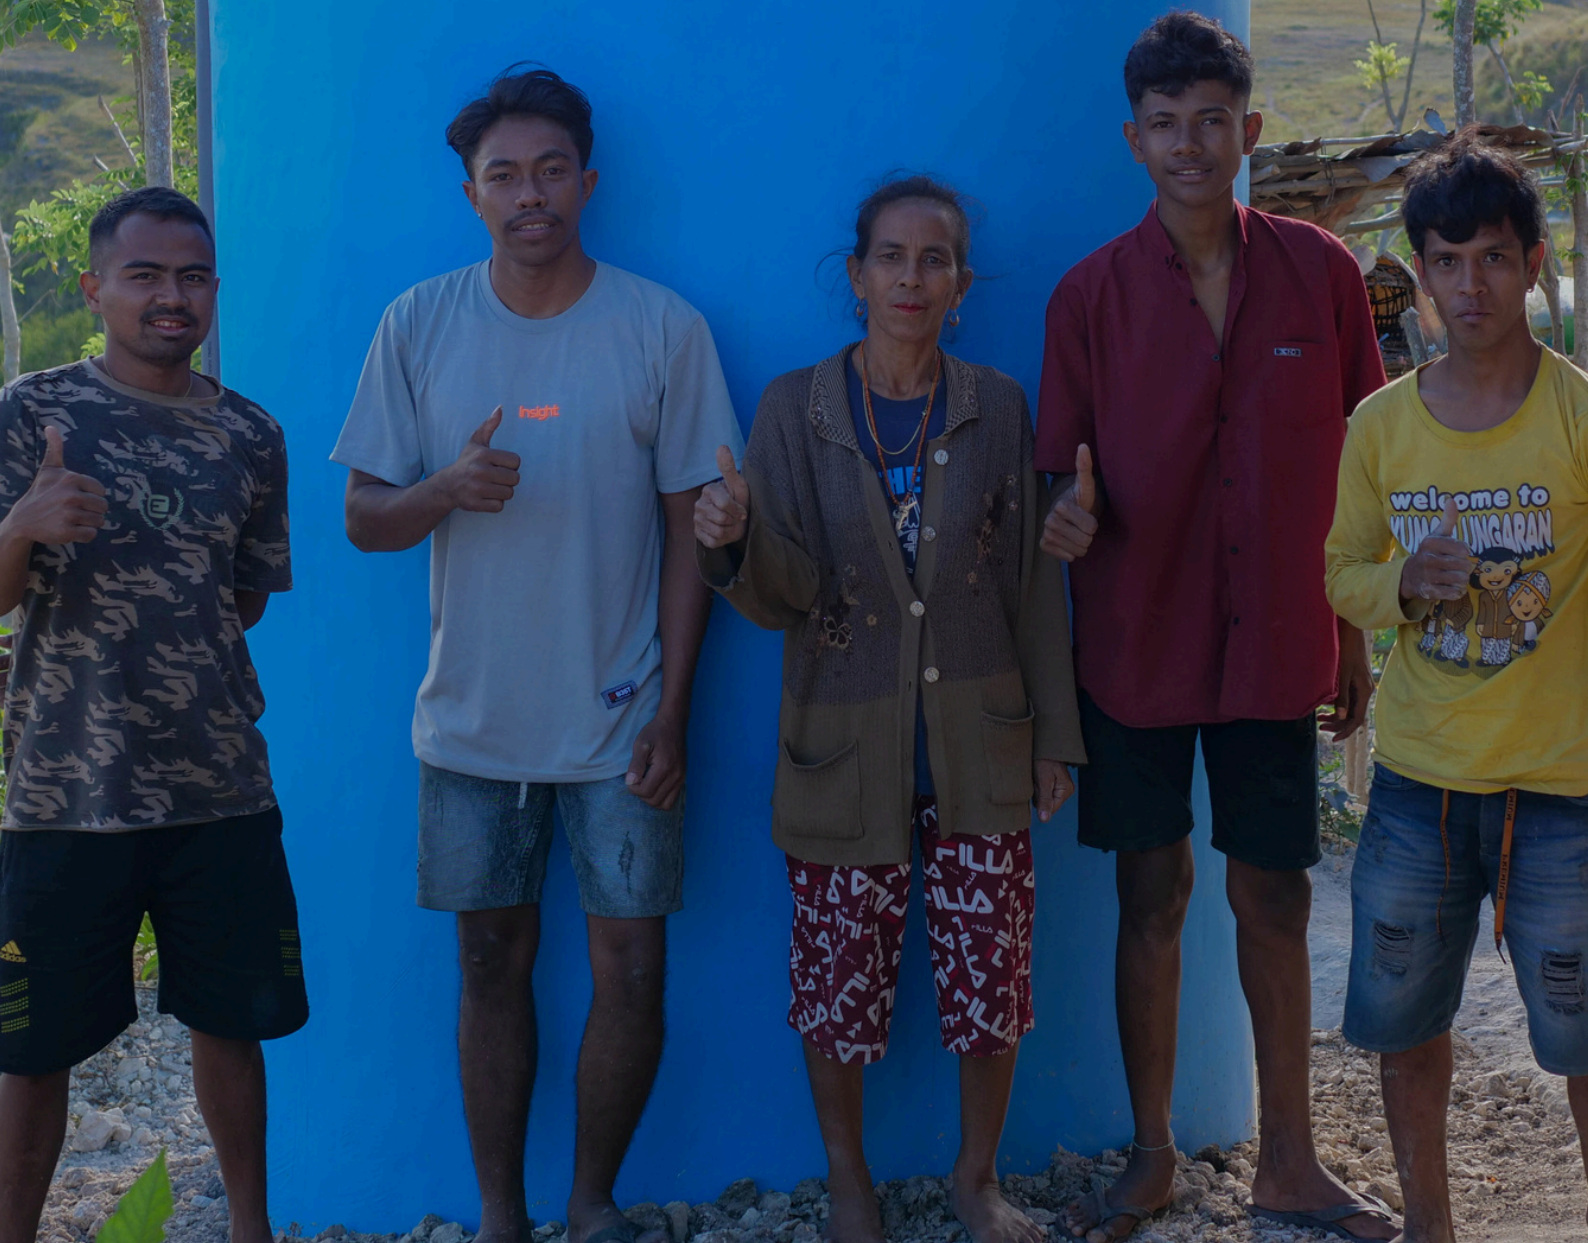
The Wai Pandulang (Rescue Water) Ferrocement Tank, which was completed on July 16, 2025, is a water tank that was built manually by the hands of local residents together with the foundation.

Located in the **Kaita Lepir** family home, this house can accommodate ±15 people. It was built using cement, sand, wire, water, and most importantly, cooperation and solidarity.

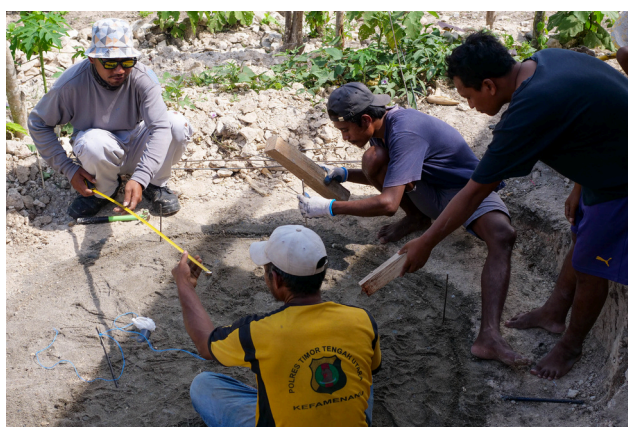
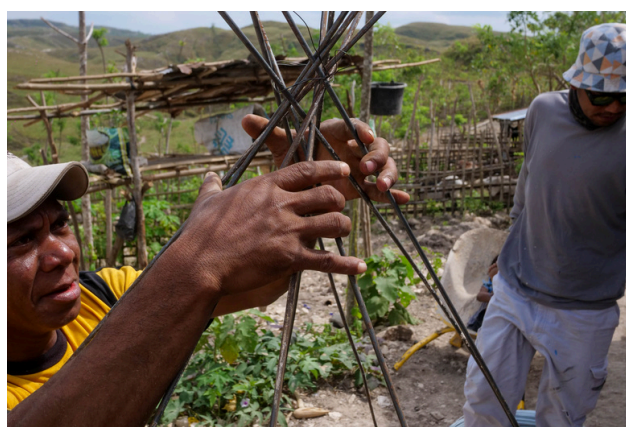
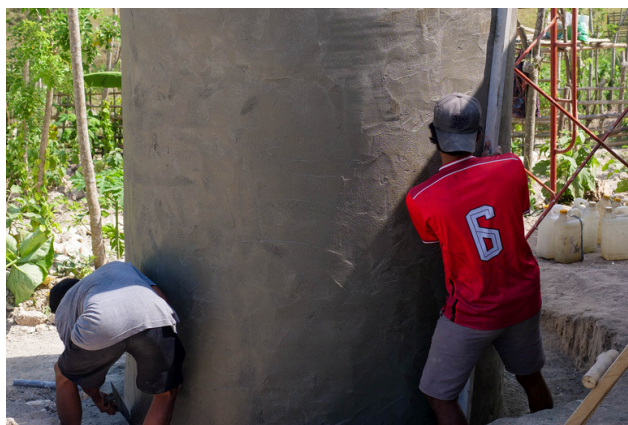
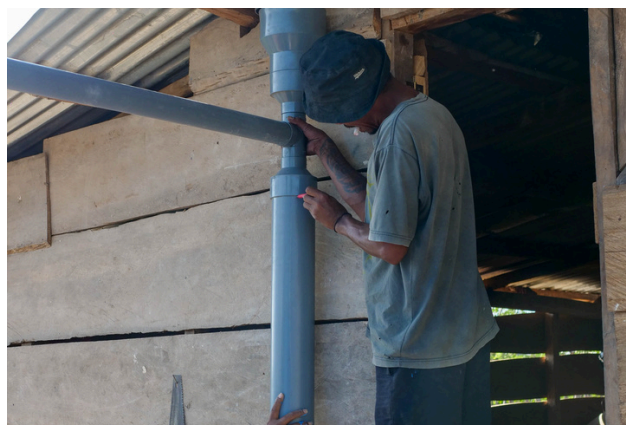
The Story of the Wai Pandulang

Construction of the ferrocement water tank in Wai Pandulang has reached approximately 90% completion, including material distribution, formwork installation, plastering, and piping installation. Technical constraints on the diameter of the ferrocement water tank were resolved by adjusting the formwork installation method to achieve a more precise shape.

The second week focused on completing the topside, including casting and installing the lid, vents, manholes, and final finishing. With the completion of this phase, the main structure of the ferrocement water tank was declared complete.
